# JOHN ROBINSON'S INSPECTION GROUP

## COMMERCIAL INSPECTION

12345 San Diego Avenue  
San Diego, Ca 92101

OCTOBER 19, 2022

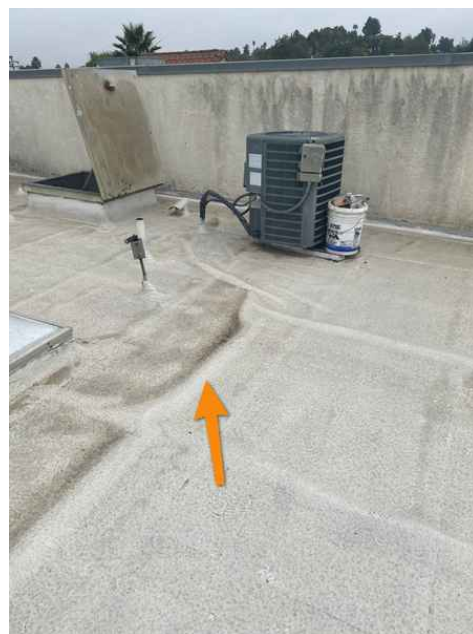
Bubbling noted at the flat portion of the roof. This can be an indication that the roof is separating from the underlayment or roof deck, and can reduce the life of the roof and lead to leaks. We recommend further evaluation by licensed roofing contractor before the removal of contingencies to determine what repairs are needed at this time and to determine if any latent defects exist.

Contact a qualified roofing professional.

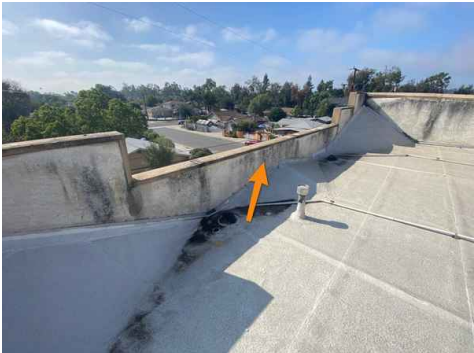
STUCCO - MOISTURE DAMAGED

Moisture damaged stucco noted at one or more locations. Unable to determine the exact cause or extent of the issue. Recommend further evaluation by a licensed stucco contractor and any corrections as necessary at this time.

Contact a stucco repair contractor

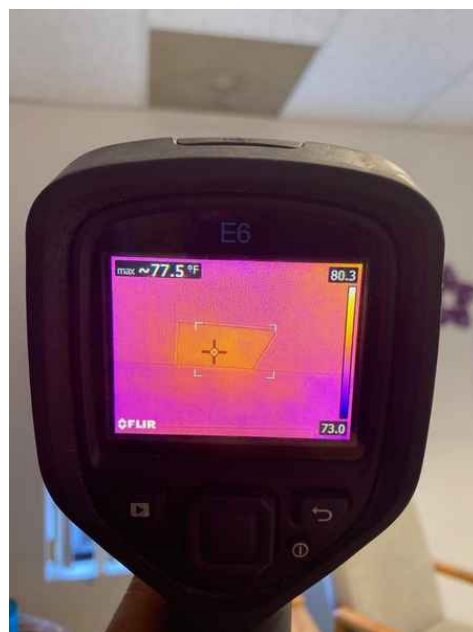
The heat pump system did not appear to be functional in heat mode. Recommend further evaluation by a licensed HVAC contractor before the removal of contingencies to determine repairs necessary at this time to ensure proper function.

Contact a qualified heating and cooling contractor

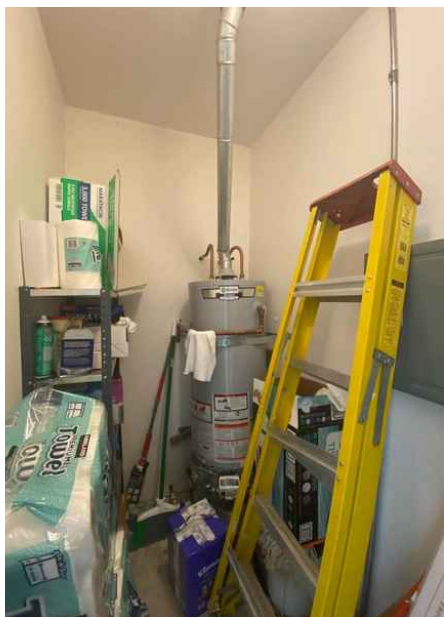
## WATER HEATERS, CONTROLS, FLUES AND VENTS: Picture of Water Heater(s)

Picture of water heater(s).

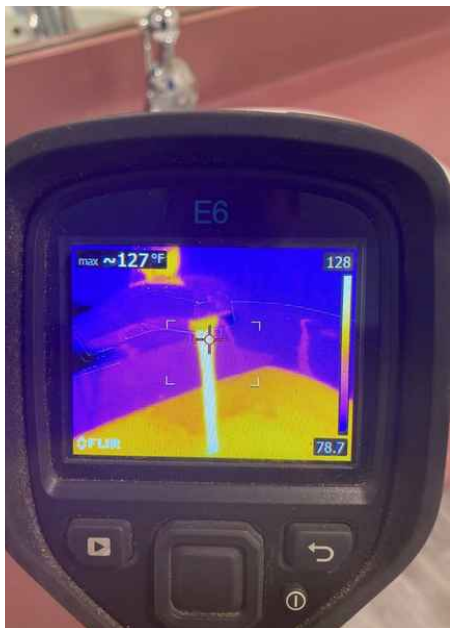
## WATER HEATERS, CONTROLS, FLUES AND VENTS: Thermal Image of Hot Water

Thermal image(s) showing the water heater(s) producing hot water at the time of the inspection.

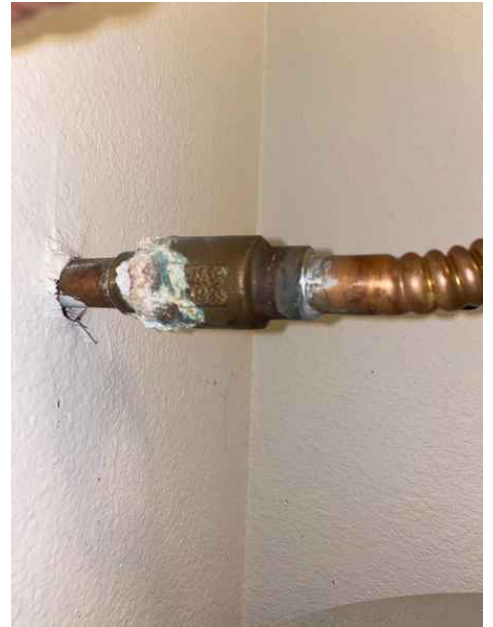
**PLUMBING - CORROSION AT WATER SUPPLY LINES**

Rust and/or corrosion noted at the water supply pipes at the water heater. This appeared to be indicative of past or ongoing leaks. We recommend further evaluation by licensed plumbing contractor before the removal of contingencies to determine what repairs are needed at this time and to determine if any latent defects exist.

Contact a qualified plumbing contractor.

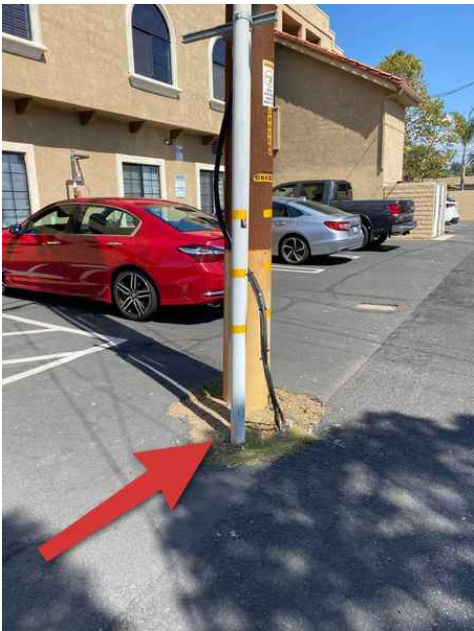
**SERVICE DROP - VEHICLE BOLLARD RECOMMENDED**

The electrical service drop is located in an area that makes it vulnerable to being hit and damaged by a vehicle. You may wish to view this for yourself. For your safety we recommend having a vehicle Ballard installed by a qualified professional to protect the service drop from impact damage

Contact a qualified professional.
